## BOARD OF WATER SUPPLY

Subject: Board of Water Supply (BWS) Comments to the Work Plans Being Developed Under the Red Hill Bulk Fuel Storage Facility Administrative Order on Consent (AOC) Statement of Work (SOW) Sections 2 through 5 and 8

The BWS and its consultants have reviewed the various reports and outlines prepared by the Navy and Defense Logistics Agency (DLA) in accordance with the AOC SOW for the sections below.

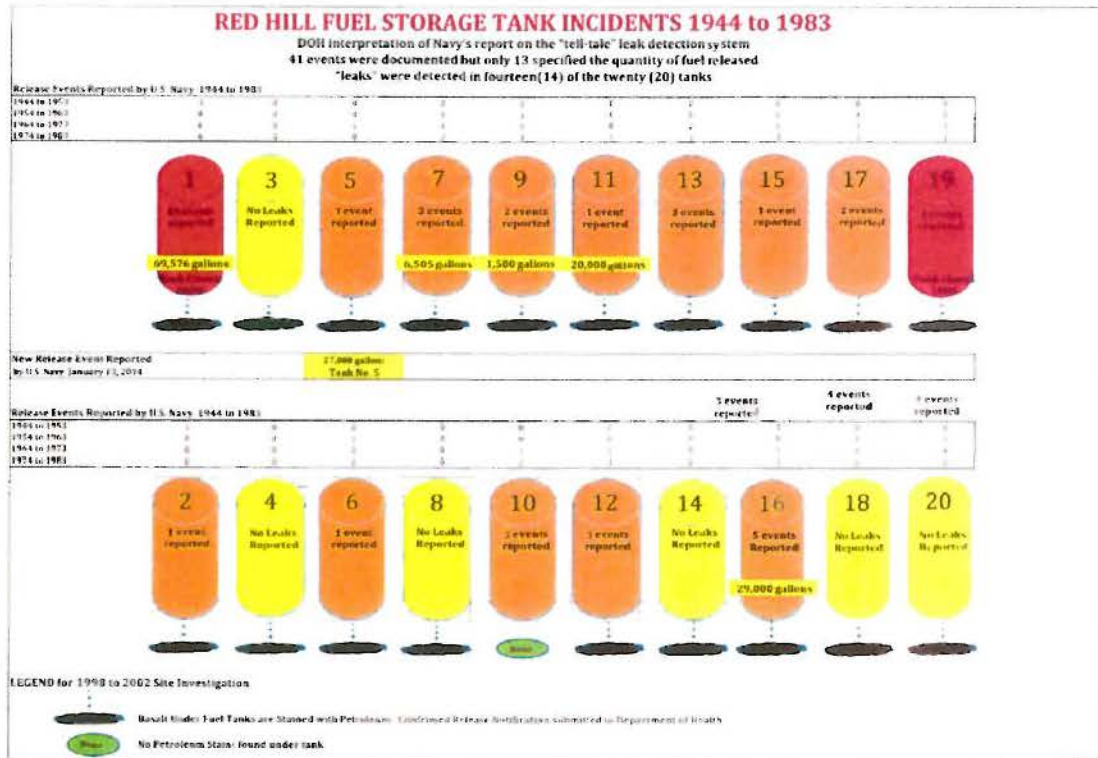
Provide a table that lists what is known about prior leaks. The Hawaii Department of Health's (DOH) chart shown below provides a basis for what should be included.
